**Flood Control Project Maintenance
Levee Inspections**
LMA District Cover Sheet
Spring 2017 Levee Inspection Results

Reclamation District No. 0785 Driver

Spring 2017 Levee Inspection Results

Waterway			Bank	Unit Miles
Unit No. 01 Sacramento River			Right	2.26
	Spring (March - May)	Summer (June - August)	(September - November) Fall	Winter (December - February)
Unit Maintenance Rating (Fall Only)				
Date of Inspection	4/13/2017 - 4/13/2017			
DWR Inspector	Zach Jojola			
Accompanied By	Oleg Yakimov DWR

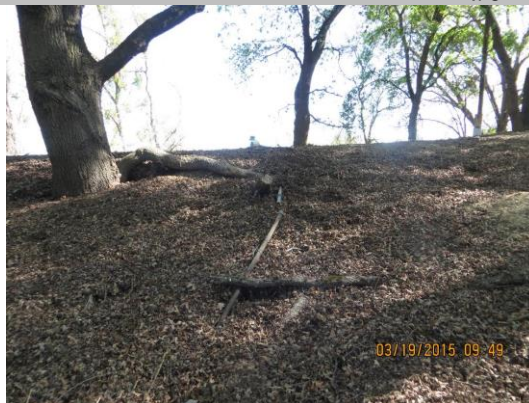
Photo 1 of 2 : UCIP_SP_2017_43965_73439.jpg

LM Start	0.00	Rating **	M	Issue No.	357
LM End	0.00	Issue Type +	En	Location *	LS
Category	Supplemental			GPS Latitude/Longitude	
				Start	End
Item	DWR UCIP Field Study			38.654407 °	38.654407 °
				-121.605937 °	-121.605937 °
DWR ID					
Comment Code					
Inspector Comment					
FS_ID:43965 DS_ID:22976 EP_NO: N/A Repair Type: Non-Urgent Crossing Status: Found UCIP Comments: Pipe appears abandoned and should be done so properly. FIELD_STRUCT_DESC: 1 of 2: 3/4-inch steel conduit through the levee 1-foot below the crown. FS Date: 3/19/2015

Pipe visible on LS slope.

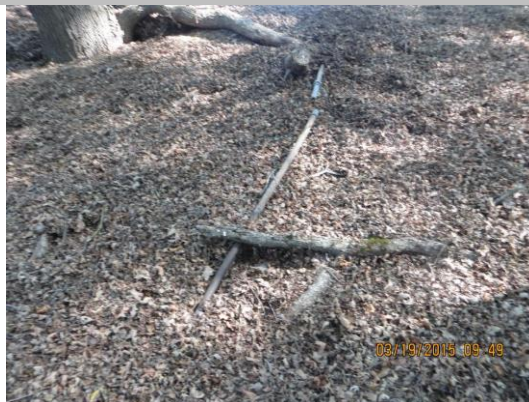
Photo 2 of 2 : UCIP_SP_2017_43965_73438.jpg

Pipe visible on LS slope.

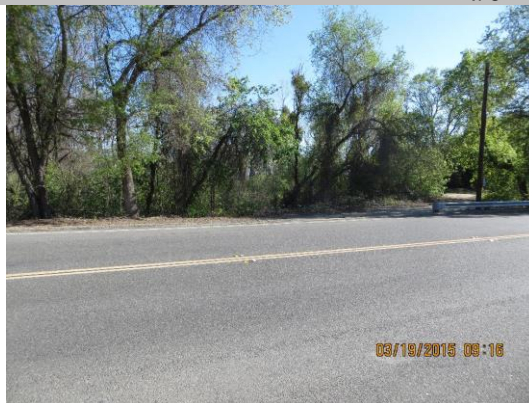
Photo 3 of 3 : UCIP_SP_2017_50617_73400.jpg

Item	DWR UCIP Field Study			38.660986 °		38.660986 °
				-121.613532 °		-121.613532 °
DWR ID						
Comment Code						
Inspector Comment						
FS_ID:50617						
DS_ID:22974						
EP_NO: N/A						
Repair Type: Urgent						
Crossing Status: Found						
UCIP Comments: 07/18/2016 Same as last inspection. Pipe is silted in as visible through the LS pumphouse. (K. Fazel - UCIP)03/19/2015						
Pipe appears to be abandoned and should be done so properly as it is open on the LS inside the pumphouse. Dense vegetation on both sides of the levee. (G. Wylie - FPIIB)						
FIELD_STRUCT_DESC: *ABANDONED* 30-inch steel pipe with an unknown purpose through the levee, 10 feet below the crown. Landside (LS) end open inside concrete pumphouse on the LS shoulder, but unable to find the pipe on the waterside (WS). [Additional Reference(s): DWR Levee Log, 1988. USACE Sacramento O&M Manual 122 - Part 1, Aug 1955 (RM 69.50)].

WS shoulder heavily vegetated. unable to search for pipe.

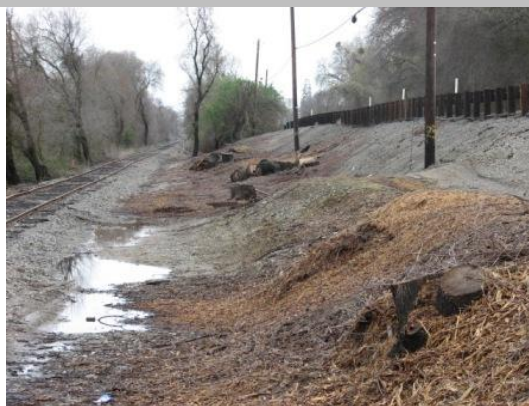
Photo 1 of 1 : SP_2017_RD0785_185_4_20170320_00003.jpg

LM Start	0.12	Rating **	N	Issue No.	4
LM End	1.34	Issue Type +	Ma	Location *	LS
Category	Earthen Levee			GPS Latitude/Longitude	
				Start	End
Item	Trim / Thin Trees			38.660160 °	38.646214 °
				-121.611619 °	-121.598596 °
DWR ID	DWR_RD0785_01_s_2012_4				
Comment Code					
T5 : Tree stumps.					
Inspector Comment

The trees were cut by PG&E'S tree contractor. The district will take care of the stumps in the future.

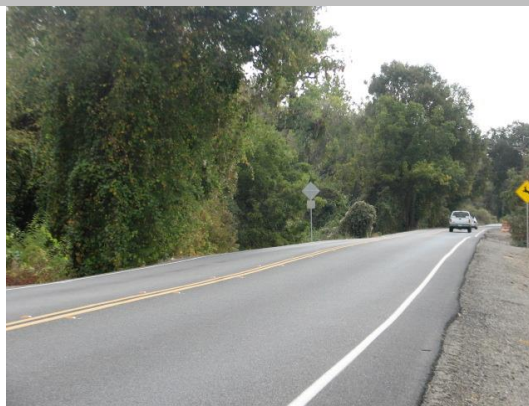
Photo 1 of 2 : SP_2017_RD0785_185_16_20170320_00013.jpg

Brush and other vegetation partially blocks visibility or access to the levee slope. Fall 2013

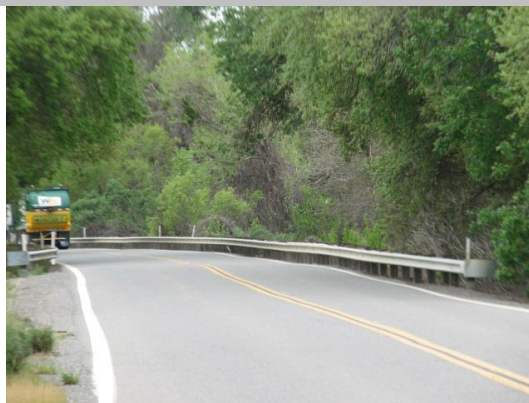
Photo 2 of 2 : SP_2017_RD0785_185_16_20170320_00014.jpg

Brush and other vegetation partially blocks visibility. Spring 2014

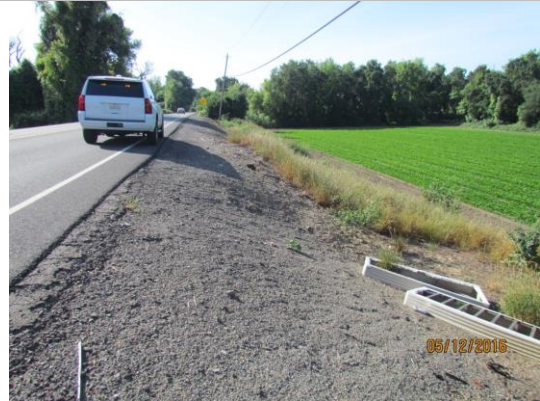
Photo 1 of 1 : SP_2017_RD0785_185_346_20170320_00049.jpg

View of the bed mattresses on the landward side of the levee looking downstream. Spring 2016.

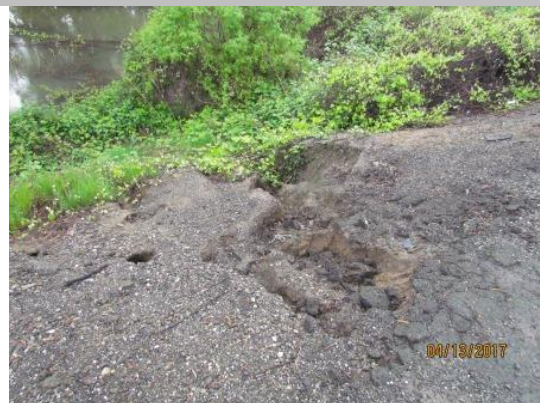
Photo 1 of 1 : SP_2017_RD0785_185_24_20170413_00065.jpg

LM Start	0.24	Rating **	U	Issue No.	24
LM End	0.24	Issue Type +	Ma	Location *	WS
Category	Earthen Levee			GPS Latitude/Longitude	
				Start	End
Item	Erosion / Bank Caving			38.658998 °	38.658998 °
				-121.610081 °	-121.610081 °
DWR ID	DWR_RD0785_01_s_2017_24				
Comment Code					
E2 : Schedule repair of erosion site prior to the next inspection.					
Inspector Comment					
Runnoff erosion on waterside slope.

Runoff erosion on waterside levee slope. Spring 2017.

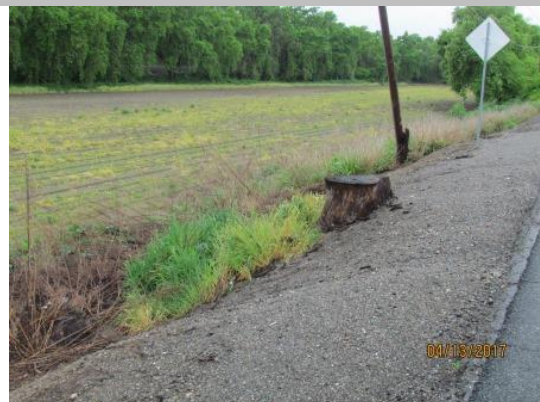
Photo 1 of 1 : SP_2017_RD0785_185_36_20170413_00066.jpg

LM Start	0.28	Rating **	N	Issue No.	36
LM End	0.28	Issue Type +	Ma	Location *	LS
Category	Earthen Levee			GPS Latitude/Longitude	
				Start	End
Item	Trim / Thin Trees			38.658537 °	38.658537 °
				-121.609675 °	-121.609675 °
DWR ID	DWR_RD0785_01_s_2017_36				
Comment Code					
T5 : Tree stumps.					
Inspector Comment

View of stump on landside levee slope. Spring 2017.

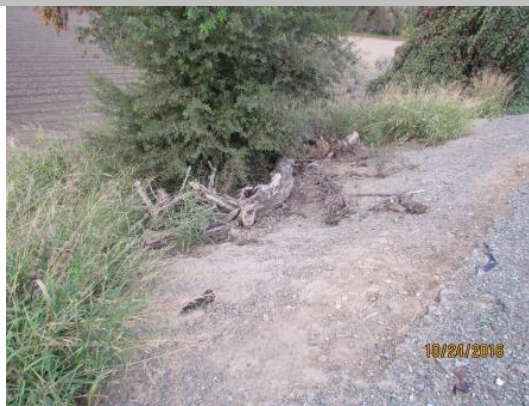
Photo 1 of 1 : SP_2017_RD0785_185_20_20170320_00015.jpg

View of a tree on LS slope. Fall 2016.

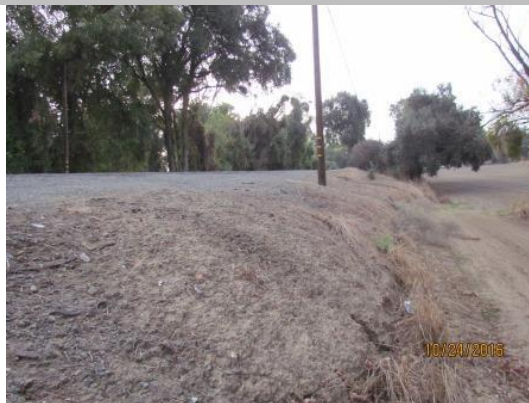
Photo 1 of 2 : SP_2017_RD0785_185_349_20170320_00050.jpg

LM Start	0.34	Rating **	M	Issue No.	349
LM End	0.34	Issue Type +	Ma	Location *	LS
Category	Earthen Levee			GPS Latitude/Longitude	
				Start	End
Item	Slope Stability			38.657798 °	38.657798 °
				-121.608898 °	-121.608898 °
DWR ID	DWR_RD0785_01_s_2015_349				
Comment Code					
S1 : Repair slope instability.					
Inspector Comment

An updated view of a slope stability issue on LS slope. Fall 2016.

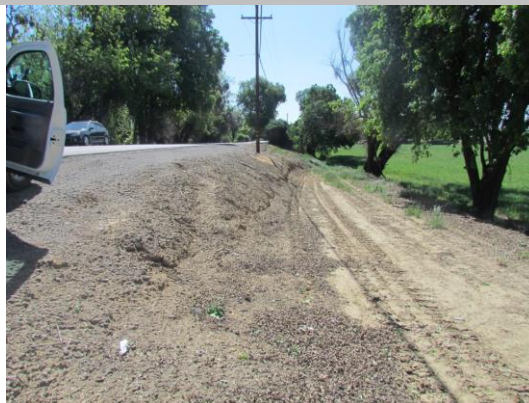
Photo 2 of 2 : SP_2017_RD0785_185_349_20170320_00051.jpg

View of the slope stability on the landward side of the levee looking downstream. Spring 2015.

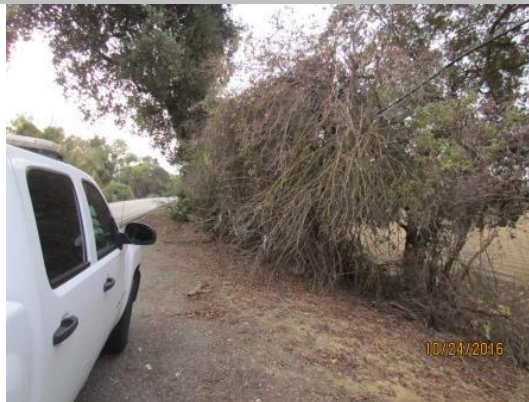
Photo 1 of 1 : SP_2017_RD0785_185_2_20170320_00002.jpg

Elderberry tree on LS slope. Fall 2016.

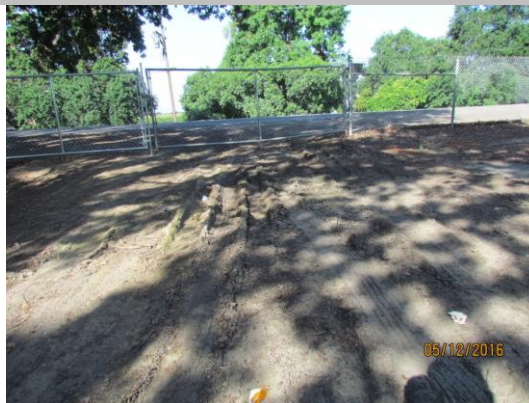
Photo 1 of 1 : SP_2017_RD0785_185_21_20170320_00016.jpg

LM Start	0.58	Rating **	M	Issue No.	21
LM End	0.58	Issue Type +	Ma	Location *	CR
Category	Earthen Levee			GPS Latitude/Longitude	
				Start	End
Item	Crown Surface / Depressions / Rutting			38.655077 °	38.655077 °
				-121.606237 °	-121.606237 °
DWR ID	DWR_RD0785_01_s_2016_21				
Comment Code					
C2 : Repair depressions or ruts in the crown or slope.					
Inspector Comment

View of the ruts on the crown of the levee. The direction of the river is upstream which is to the left of the picture. Spring 2016.

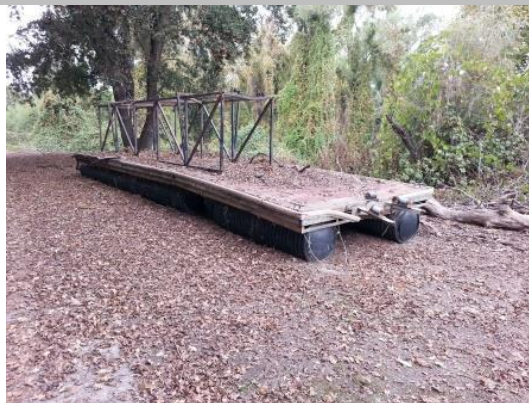
Photo 1 of 2 : SP_2017_RD0785_185_351_20170320_00053.jpg

Updated view of old dock on crown/waterward side. Fall 2016.

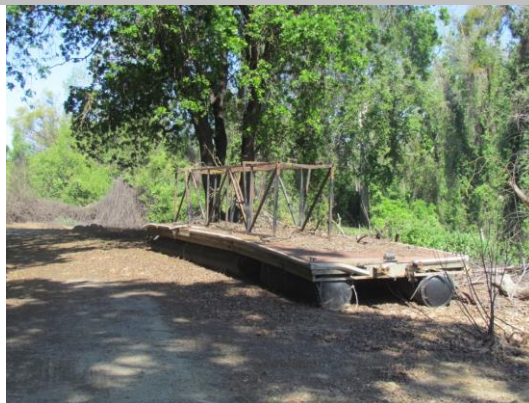
Photo 2 of 2 : SP_2017_RD0785_185_351_20170320_00054.jpg

View of a old dock on the waterward side of the levee looking upstream.
Spring 2015.

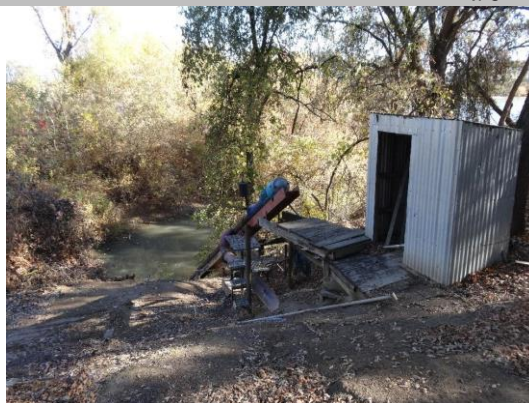
Photo 1 of 3 : UCIP_SP_2017_43963_45628.jpg

LM Start	0.63	Rating **	M	Issue No.	359
LM End	0.63	Issue Type +	En	Location *	WS
Category	Supplemental			GPS Latitude/Longitude	
				Start	End
Item	DWR UCIP Field Study			38.654641 °	38.654641 °
				-121.605538 °	-121.605538 °
DWR ID					
Comment Code					
Inspector Comment					
FS_ID:43963					
DS_ID:22982					
EP_NO: N/A					
Repair Type: Non-Urgent					
Crossing Status: Found					
UCIP Comments: Part of abandoned pipe also found on waterside that should be removed.No access to landside across the highway.					
FIELD_STRUCT_DESC: 2 of 2: 12-inch steel irrigation pipe through the levee, 11.0-feet below the crown, slant pump on the waterside slope.					
Pipe crosses under highway fill and discharge into irrigation ditch.					
FS Date: 11/21/2013

WS view: slant pump, walkway, and electric control box in shed on levee slope.

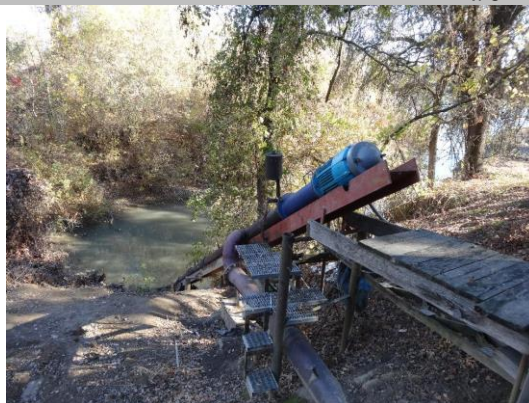
Photo 2 of 3 : UCIP_SP_2017_43963_45627.jpg

WS view: slant pump and walkway on levee slope.

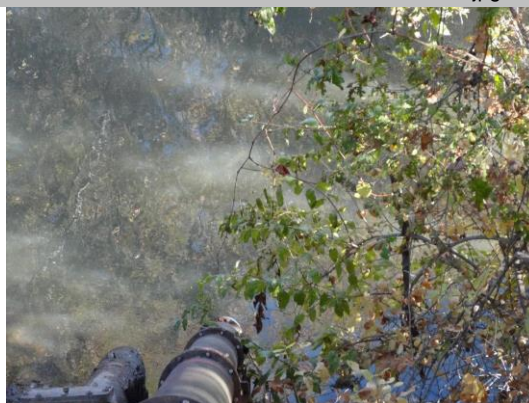
Photo 3 of 3 : UCIP_SP_2017_43963_45626.jpg

WS view: two steel pipes on levee slope. Abandoned pipe on left.

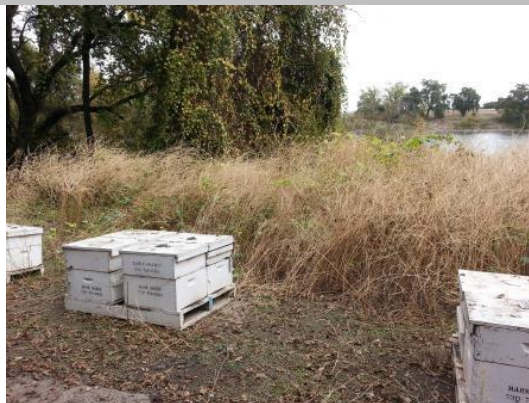
Photo 1 of 1 : SP_2017_RD0785_185_51_20170320_00047.jpg

View of vegetation site on WS slope. Fall 2016.

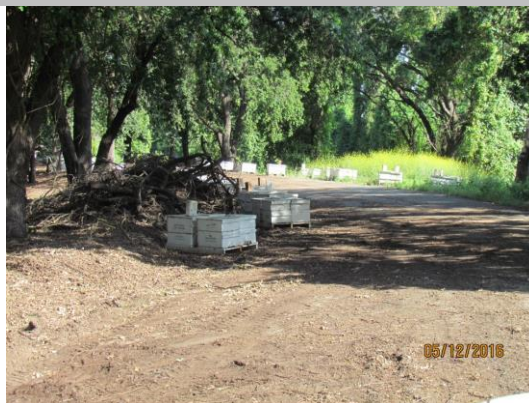
Photo 1 of 1 : SP_2017_RD0785_185_350_20170320_00052.jpg

View of the beehives on the crown of the levee looking upstream. Spring 2016.

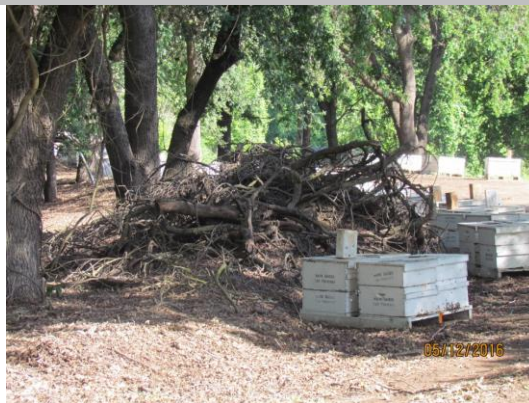
Photo 2 of 2 : SP_2017_RD0785_185_14_20170320_00012.jpg

View of the pruning pile on the landward side of the levee looking upstream. Spring 2016.

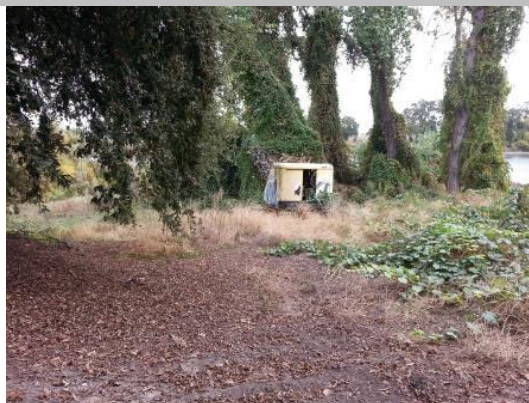
Photo 1 of 1 : SP_2017_RD0785_185_49_20170320_00046.jpg

View of an abandoned crane on waterward side of the levee. Fall 2016.

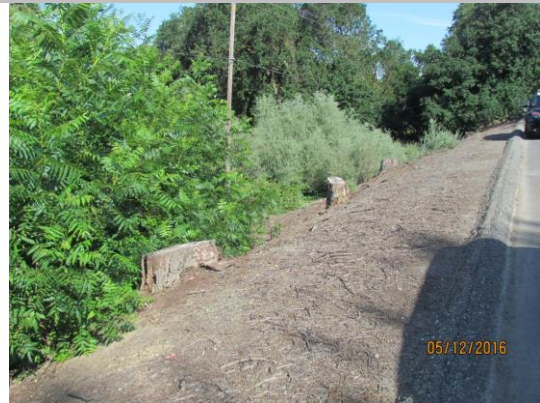
Photo 1 of 1 : SP_2017_RD0785_185_181_20170320_00048.jpg

View of the tree stumps on the landward side of the levee looking upstream. Spring 2016.

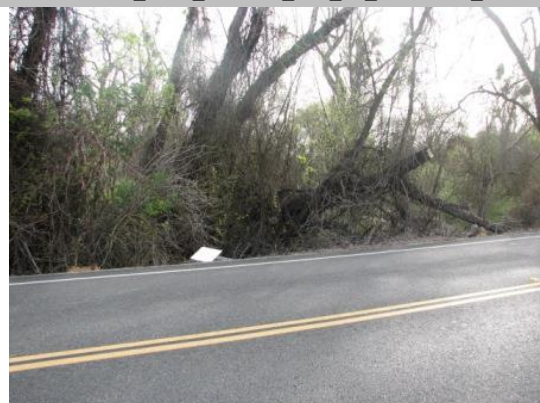
Photo 1 of 1 : SP_2017_RD0785_185_47_20170320_00042.jpg

The fallen tree and brush on the waterside of the roadway needs to be removed. Photo taken spring 2012.

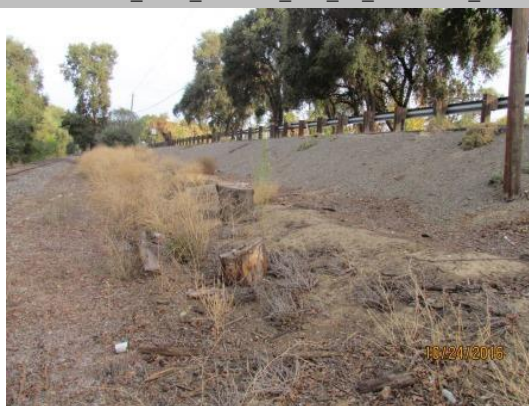
Photo 1 of 1 : SP_2017_RD0785_185_28_20170320_00022.jpg

Two decomposing tree stumps near levee toe on landside. Fall 2016.

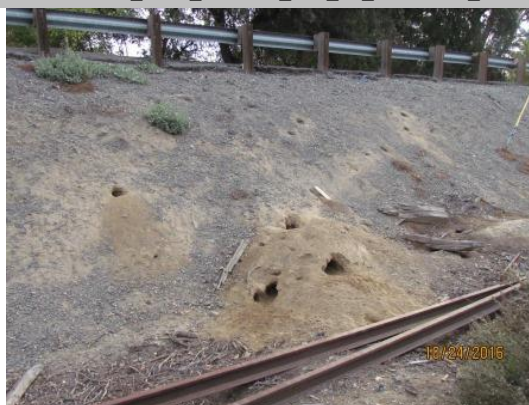
Photo 1 of 2 : SP_2017_RD0785_185_29_20170320_00023.jpg

View of rodent holes on LS slope. Fall 2016.

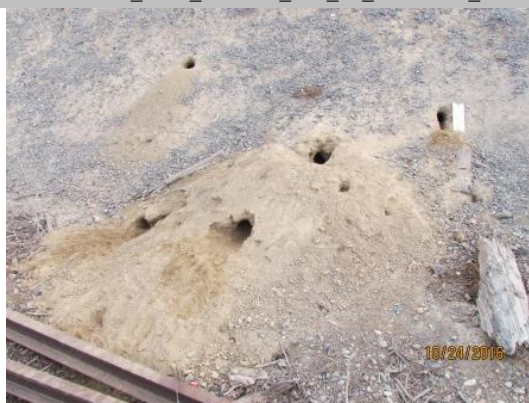
Photo 2 of 2 : SP_2017_RD0785_185_29_20170320_00024.jpg

Another view of rodent holes. Fall 2016.

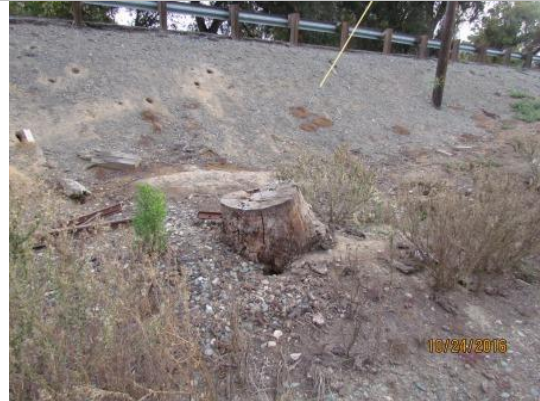
Photo 1 of 1 : SP_2017_RD0785_185_30_20170320_00025.jpg

View of a decomposing stump near levee toe on landside. Fall 2016.

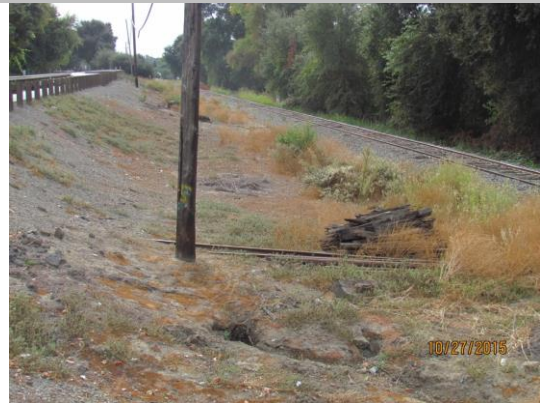
Photo 1 of 1 : SP_2017_RD0785_185_12_20170320_00007.jpg

View of the railroad ties and rails at the toe of the landward side of the levee looking downstream. Fall 2015.

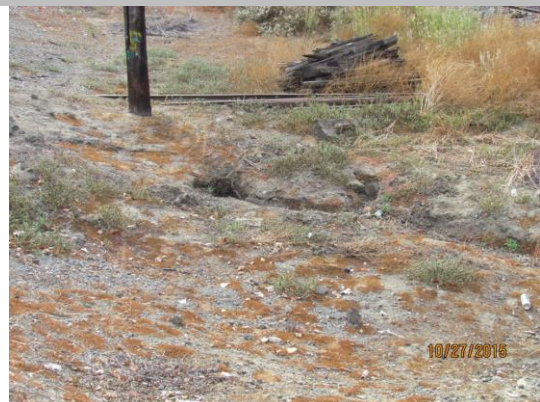
Photo 1 of 3 : SP_2017_RD0785_185_48_20170320_00043.jpg

LM Start	1.07	Rating **	M	Issue No.	48
LM End	1.07	Issue Type +	Ma	Location *	LS
Category	Earthen Levee			GPS Latitude/Longitude	
				Start	End
Item	Erosion / Bank Caving			38.649392 °	38.649392 °
				-121.601636 °	-121.601636 °
DWR ID	DWR_RD0785_01_s_2012_48				
Comment Code					
E2 : Schedule repair of erosion site prior to the next inspection.					
Inspector Comment

View of the erosion at the toe of the levee on the landward side of the levee looking downstream. Fall 2015.

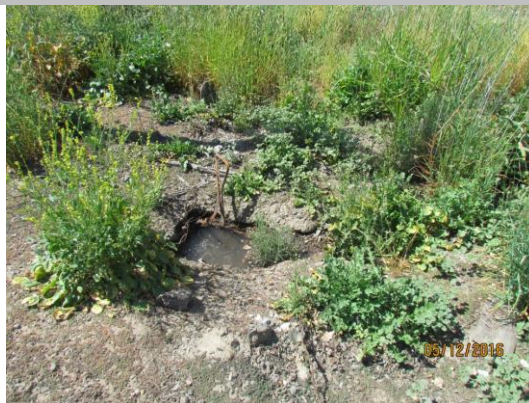
Photo 2 of 3 : SP_2017_RD0785_185_48_20170320_00044.jpg

Drain pipe is causing erosion on the landward side of the levee between the Isope and railroad tracks. Spring 2016.

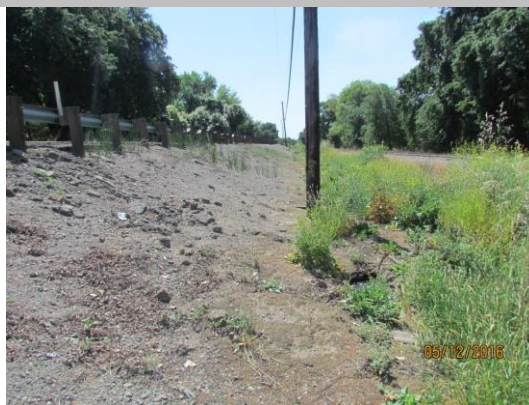
Photo 3 of 3 : SP_2017_RD0785_185_48_20170320_00045.jpg

Perspective view of the erosion on the landward side of the levee looking downstream. Spring 2016.

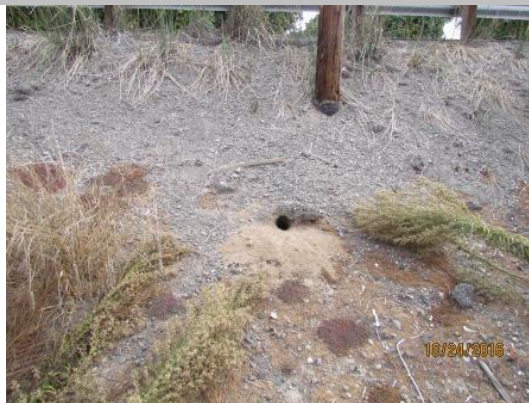
Photo 1 of 1 : SP_2017_RD0785_185_32_20170320_00027.jpg

View of rodent hole on LS slope. Fall 2016.

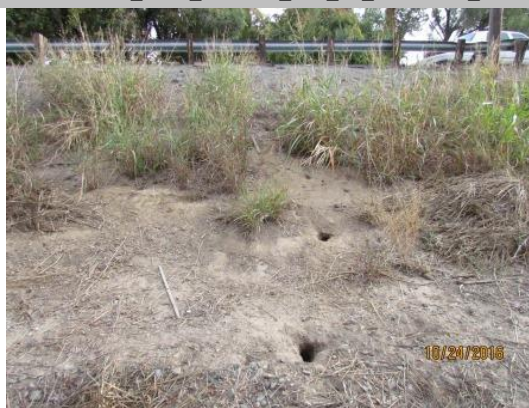
Photo 1 of 1 : SP_2017_RD0785_185_33_20170320_00028.jpg

View of rodent holes on LS slope. Fall 2016.

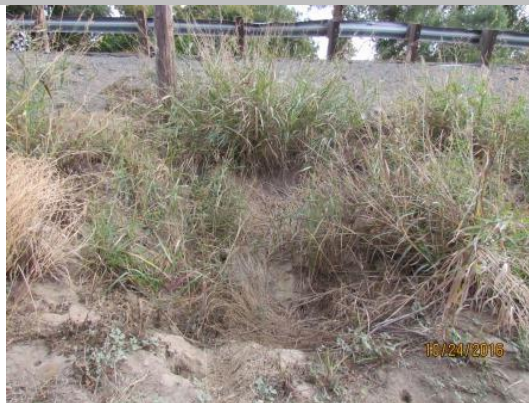
Photo 1 of 2 : SP_2017_RD0785_185_34_20170320_00029.jpg

LM Start	1.17	Rating **	U	Issue No.	34
LM End	1.17	Issue Type +	Ma	Location *	LS
Category	Earthen Levee			GPS Latitude/Longitude	
				Start	End
Item	Erosion / Bank Caving			38.648090 °	38.648090 °
				-121.600650 °	-121.600650 °
DWR ID	DWR_RD0785_01_f_2016_34				
Comment Code					
E2 : Schedule repair of erosion site prior to the next inspection.					
Inspector Comment					
LS slope erosion at pipe crossing. Pipe is not found in UCIP inventory.

Erosion of LS slope approximately above a steel pipe. Fall 2016.

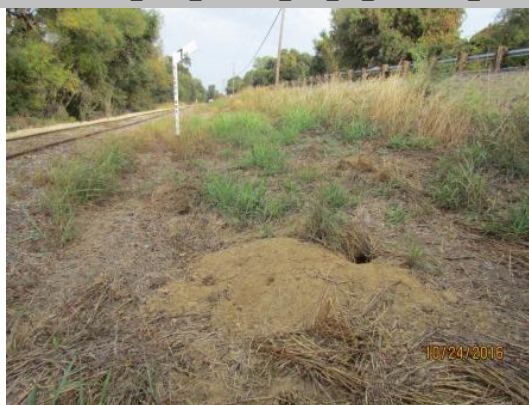
Photo 1 of 1 : SP_2017_RD0785_185_37_20170320_00032.jpg

View of a rodent hole on landward side of the levee. Fall 2016.

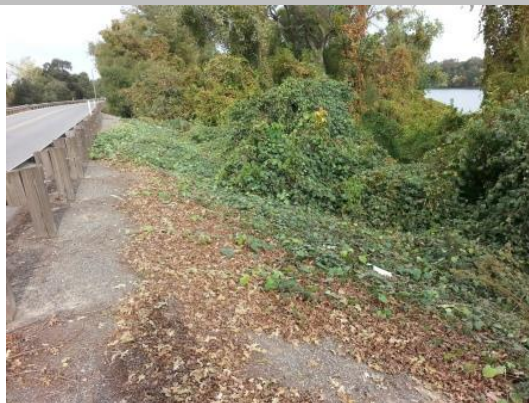
Photo 1 of 2 : SP_2017_RD0785_185_44_20170320_00038.jpg

Elderberry trees on WS slope Fall 2016.

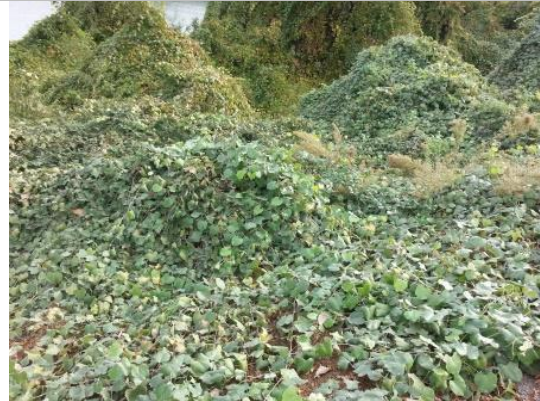
Photo 2 of 2 : SP_2017_RD0785_185_44_20170320_00039.jpg

Elderberry trees on WS slope. Fall 2016.

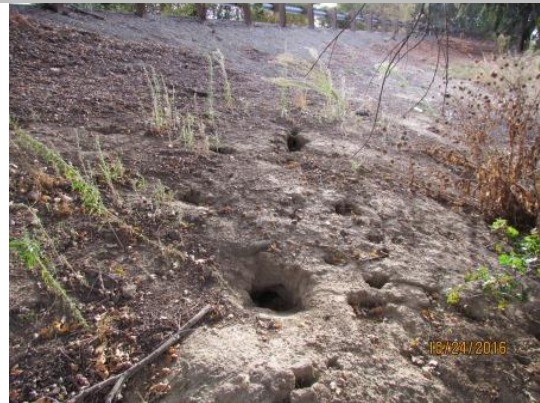
Photo 1 of 1 : SP_2017_RD0785_185_35_20170320_00031.jpg

View of rodent holes on LS slope. Fall 2016.

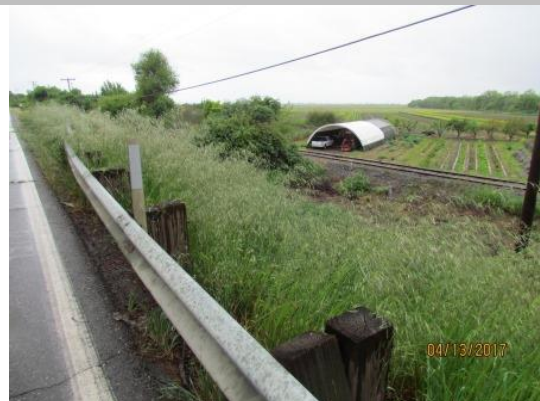
Photo 1 of 1 : SP_2017_RD0785_185_55_20170413_00067.jpg

Tall vegetation on landside levee slope, blocking visibility. Spring 2017.

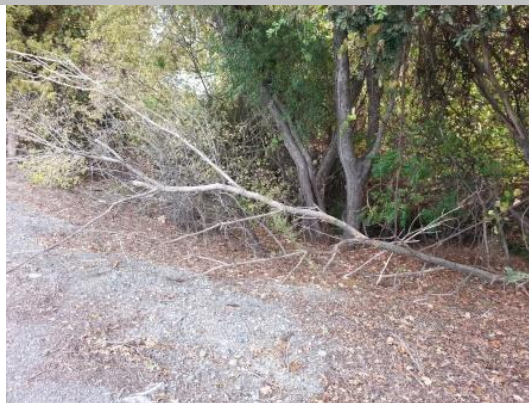
Photo 1 of 1 : SP_2017_RD0785_185_43_20170320_00037.jpg

View of fallen tree on WS slope. Fall 2016.

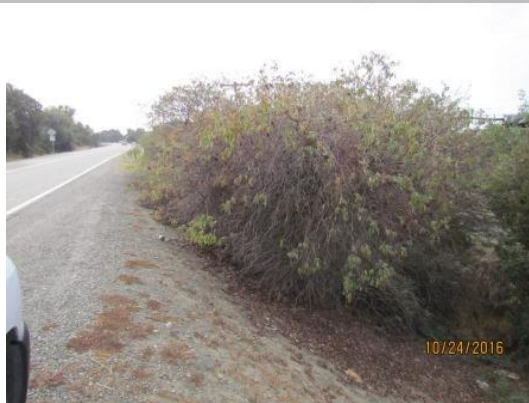
Photo 1 of 1 : SP_2017_RD0785_185_6_20170320_00004.jpg

View of elderberry trees on LS slope. Fall 2016.

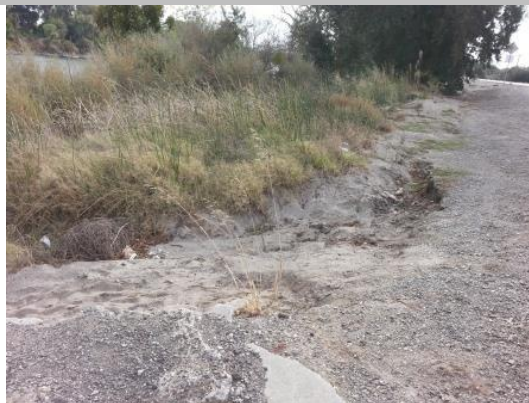
Photo 1 of 3 : SP_2017_RD0785_185_13_20170320_00008.jpg

LM Start	1.31	Rating **	M	Issue No.	13
LM End	1.31	Issue Type +	Ma	Location *	WS
Category	Earthen Levee			GPS Latitude/Longitude	
				Start	End
Item	Slope Stability			38.646671 °	38.646671 °
				-121.598915 °	-121.598915 °
DWR ID	DWR_RD0785_01_s_2013_13				
Comment Code					
S2 : Repair the levee slope damaged by foot traffic and prevent access where possible.					
Inspector Comment

Updated view of the slope stability site. Fall 2016.

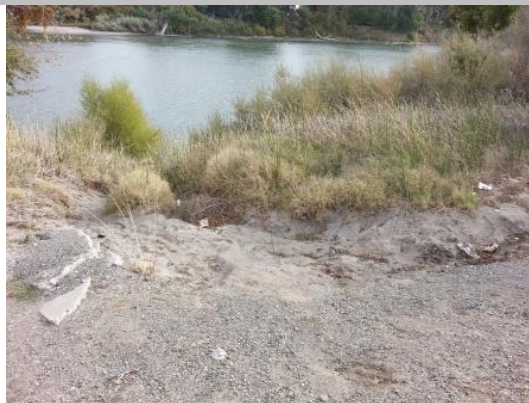
Photo 2 of 3 : SP_2017_RD0785_185_13_20170320_00009.jpg

Updated view of the slope stability site. Fall 2016.

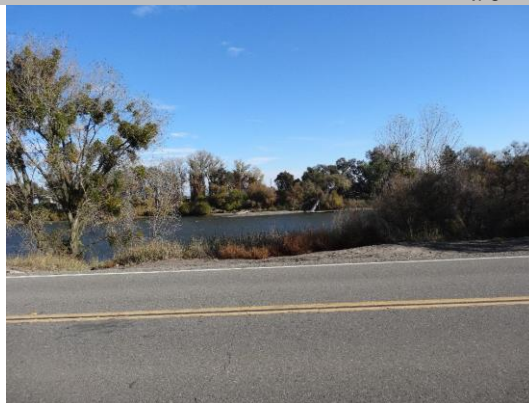
Photo 1 of 2 : UCIP_SP_2017_41984_44484.jpg

LM Start	1.31	Rating **	M	Issue No.	360
LM End	1.31	Issue Type +	En	Location *	WS
Category	Supplemental			GPS Latitude/Longitude	
				Start	End
Item	DWR UCIP Field Study			38.646547 °	38.646547 °
				-121.598924 °	-121.598924 °
DWR ID					
Comment Code					
Inspector Comment					
FS_ID:41984 DS_ID:22978 EP_NO: N/A Repair Type: Non-Urgent Crossing Status: Found UCIP Comments: Dense vegetation on waterside. No pipe found/visible on waterside. FIELD_STRUCT_DESC: 12-inch steel pipe through levee, 6.0 feet below crown. Plate bolted on both ends. FS Date: 11/21/2013

WS view: crown and waterside. No pipe found due to dense vegetation.

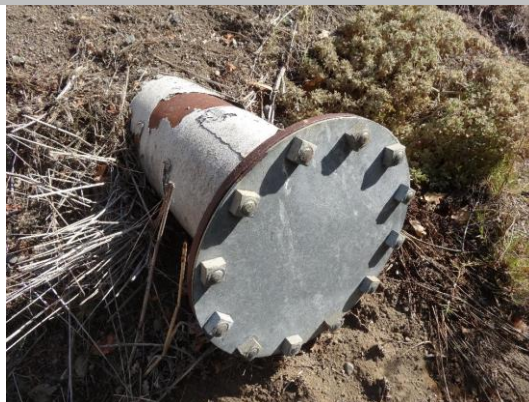
Photo 2 of 2 : UCIP_SP_2017_41984_44483.jpg

LS view: plate bolted pipe on levee slope.

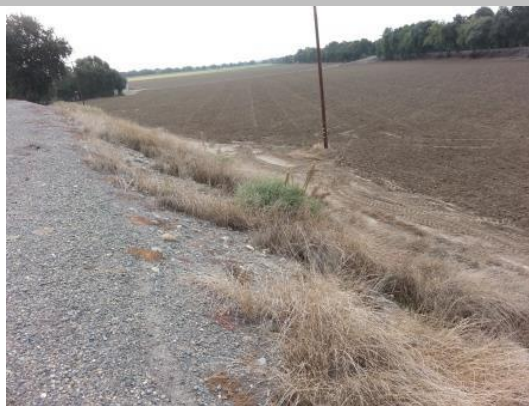
Photo 1 of 1 : SP_2017_RD0785_185_39_20170320_00034.jpg

View of vegetation of LS slope. Fall 2016.

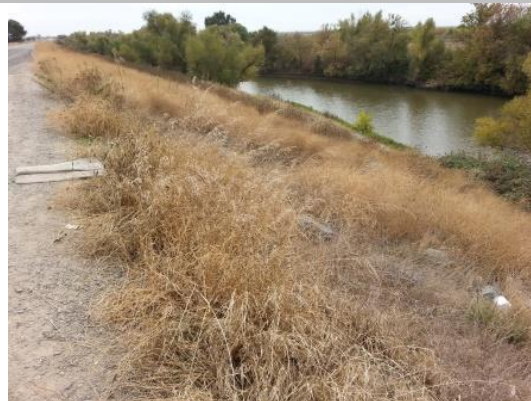
Photo 1 of 1 : SP_2017_RD0785_186_5_20170320_00001.jpg

View of vegetation on WS slope. Unable to see through vegetation. Fall 2016.

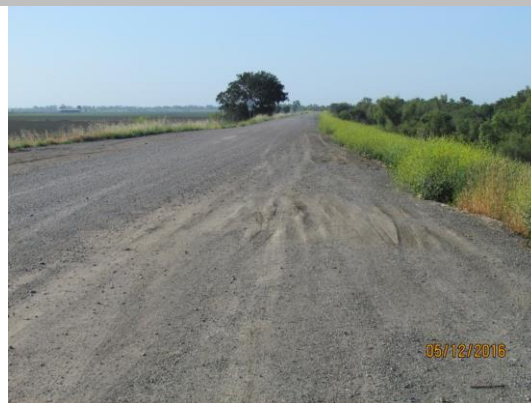
Photo 1 of 1 : SP_2017_RD0785_186_8_20170320_00004.jpg

View of the ruts on the crown of the levee looking downstream. Spring 2016.

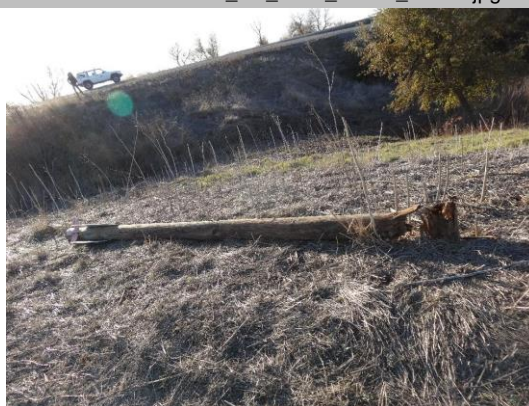
Photo 1 of 2 : UCIP_SP_2017_24750_44372.jpg

LS view: damaged indicator post across the levee road.

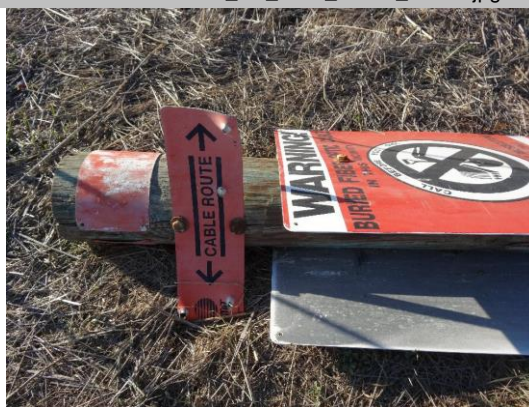
Photo 2 of 2 : UCIP_SP_2017_24750_44371.jpg

LS view: closer view of damaged indicator post.

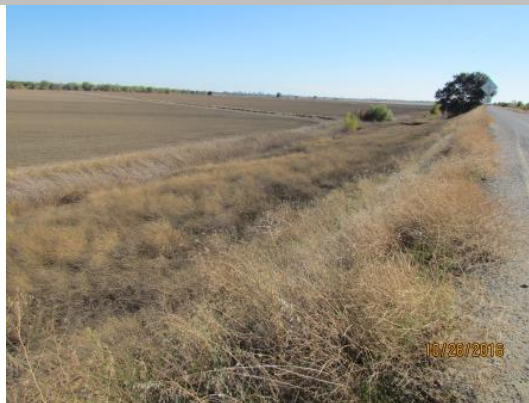
Photo 1 of 1 : SP_2017_RD0785_186_6_20170320_00002.jpg

View of dense vegetation on landside slope. Fall 2016.

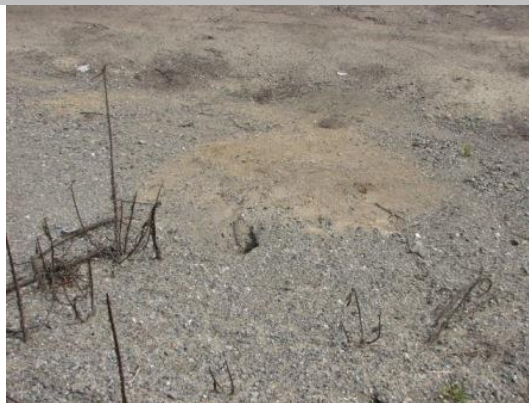
Photo 1 of 1 : SP_2017_RD0785_186_25_20170320_00015.jpg

Rodent holes on the landside levee slope, photo taken spring 2012.

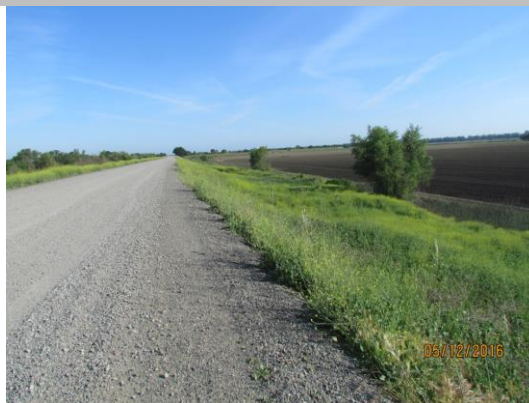
Photo 1 of 1 : SP_2017_RD0785_186_280_20170320_00031.jpg

View of the slope stability on the landward side of the levee looking upstream. Spring 2016.

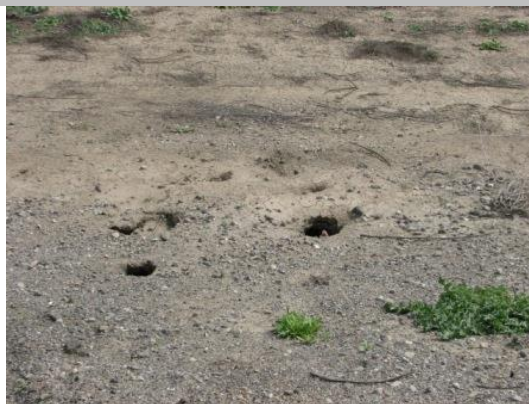
Photo 1 of 1 : SP_2017_RD0785_186_27_20170320_00016.jpg

Rodent holes on the landside levee slope, photo taken spring 2012.

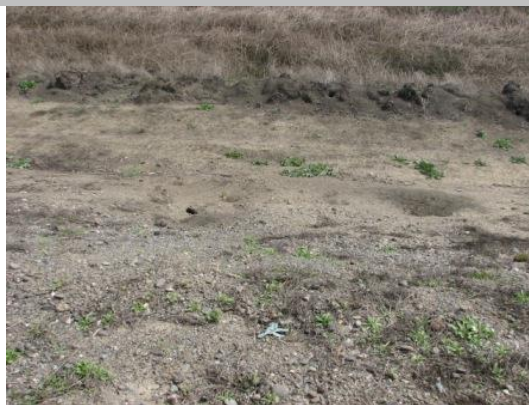
Photo 2 of 2 : SP_2017_RD0785_186_28_20170320_00018.jpg

Rodent holes on the landside levee slope, photo taken spring 2012.

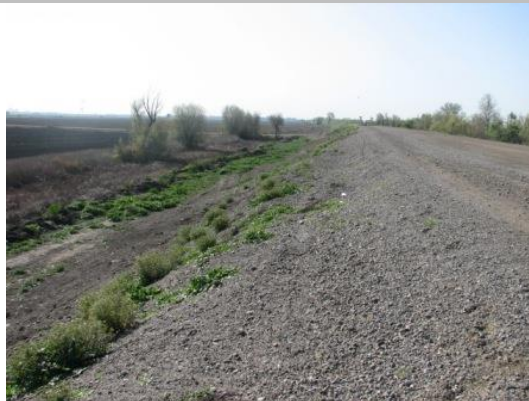
Photo 1 of 2 : SP_2017_RD0785_186_29_20170320_00019.jpg

Slope instability at shoulder of landside levee bulge at toe.

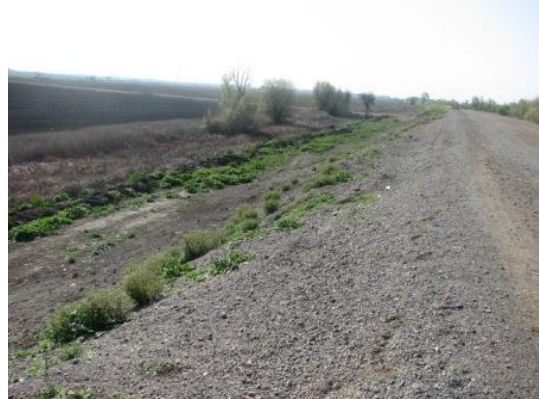
Photo 2 of 2 : SP_2017_RD0785_186_29_20170320_00020.jpg

Bulge at the landside toe of the levee, photos taken spring 2012.

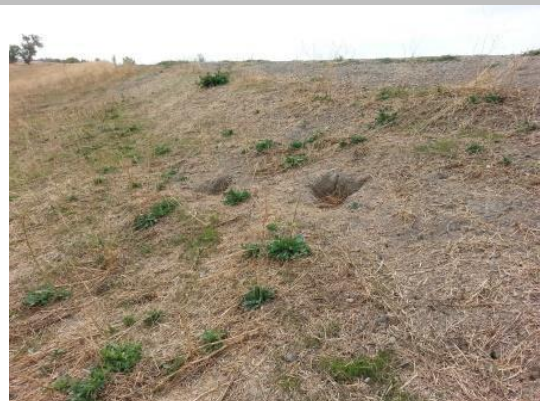
Photo 1 of 2 : SP_2017_RD0785_186_42_20170320_00026.jpg

View of rodent holes on LS slope. Holes are partially filled with soil and dry weeds/ grass. No evidence of rodent activity. Fall 2016.

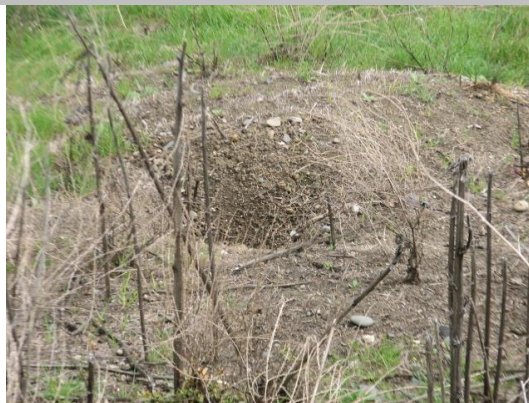
Photo 2 of 2 : SP_2017_RD0785_186_42_20170320_00027.jpg

Large rodent hole close to the toe of the levee. Spring 2014

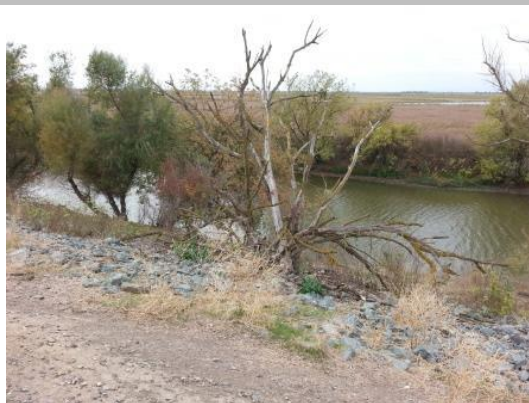
Photo 1 of 1 : SP_2017_RD0785_186_13_20170320_00010.jpg

View of dry tree on waterward slope. Fall 2016.

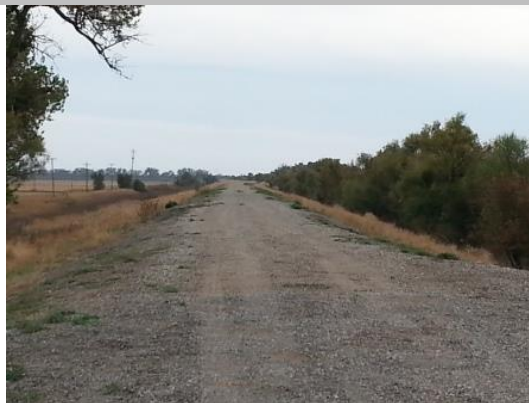
Photo 1 of 1 : SP_2017_RD0785_186_14_20170320_00011.jpg

Ruts on the crown. Fall 2016.

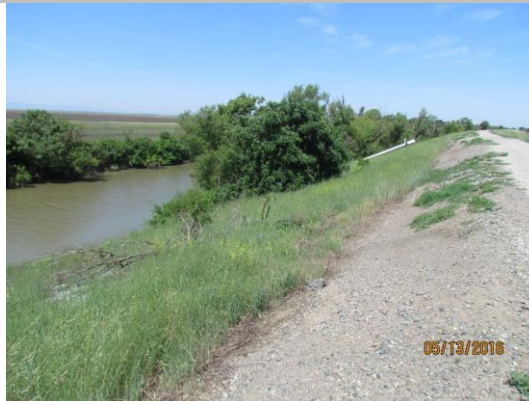
Photo 2 of 2 : SP_2017_RD0785_186_10_20170320_00008.jpg

Perspective view of the discarded tree looking upstream. Spring 2016.

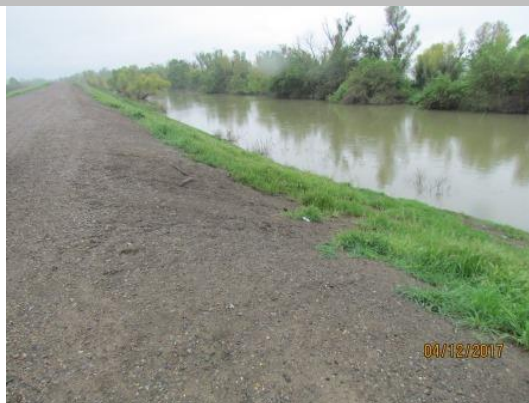
Photo 1 of 1 : SP_2017_RD0785_186_24_20170413_00034.jpg

View of slope stability on waterside levee slope. Spring 2017.

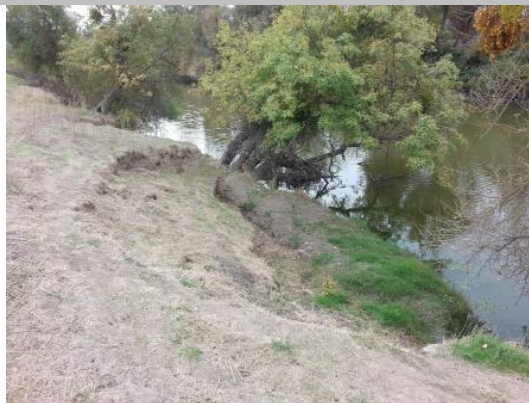
Photo 1 of 1 : SP_2017_RD0785_186_17_20170320_00012.jpg

View of erosion site on waterward side of the levee. Fall 2016.

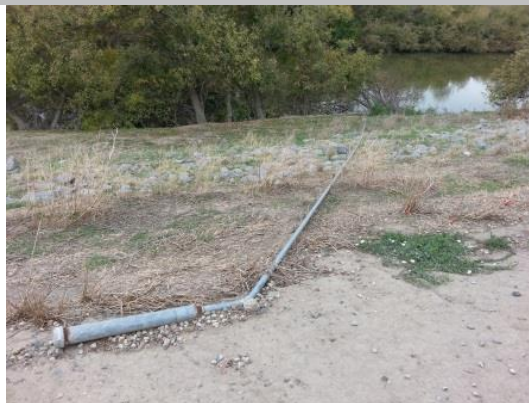
Photo 1 of 1 : SP_2017_RD0785_186_19_20170320_00014.jpg

View of a capped galvanized pipe on WS slope. Fall 2016.

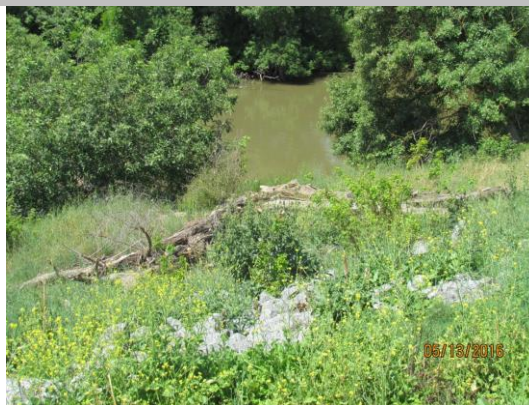
Photo 2 of 3 : SP_2017_RD0785_186_56_20170320_00029.jpg

Discarded tree is on the slope of the waterward side of the levee. Spring 2016.
